Asset Management Assessment

Final Report

Town of Amherst

**TOWN OF AMHERST
ASSET MANAGEMENT ASSESSMENT**

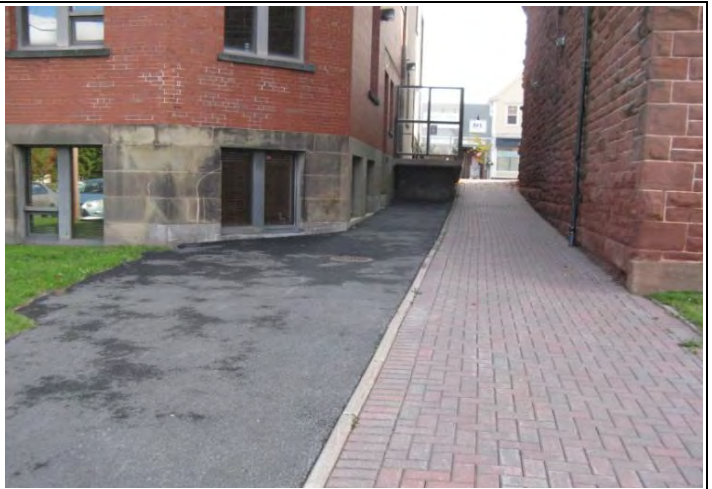
Subject	Observations/Comments	Recommendations	Photo Reference
Parking Lot	<ul style="list-style-type: none"> The Town Hall has one large parking lot at the rear of the building. This lot is maintained by the Town of Amherst. Half of this lot is rented out for public parking and the other half is for staff at the Town Hall. The section of the lot used for public parking is in poor condition with visible alligator cracking in various areas. The lot used for Town Hall staff is in moderate condition with some cracking evident. 	<ul style="list-style-type: none"> Patch areas in the public lot where deterioration is evident within the next year. 	C-01

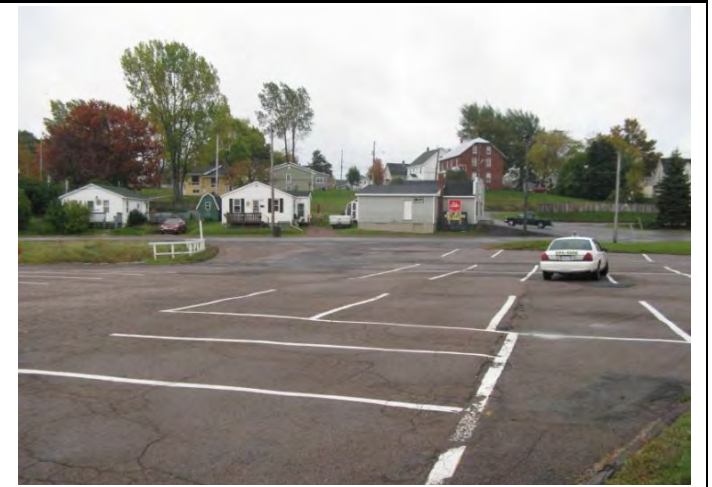
Subject	Observations/Comments	Recommendations	Photo Reference
Parking Lot	<ul style="list-style-type: none"> The Fire Hall has a large main parking lot (south) for public/staff as well as a front lot with truck bays and a few parking spaces. The rear of the building (east) also has two truck bays with no area for public parking. The main public parking lot (south) is in moderate condition with visible alligator cracking and patchwork. The front facing lot is in moderate condition as well with some visible patch work and cracking. The lot at the back of the building (east) consists of an asphalt area which transitions to a gravel lot. The area where the lots transition contains pieces of loose, broken asphalt. Large potholes were visible in the gravel area of the lot. Both concrete and asphalt curb were noted at different locations around the building/parking lots. The existing curb is in moderate condition with some visible cracking and missing pieces. 	<ul style="list-style-type: none"> East and South lots may require repaving in the next 5-10 years. Patch areas where necessary. Back lot with asphalt that transitions to gravel should be cleaned up (i.e., remove loose asphalt pieces) and re-grade gravel areas with large potholes. 	C-03 C-04 C-05

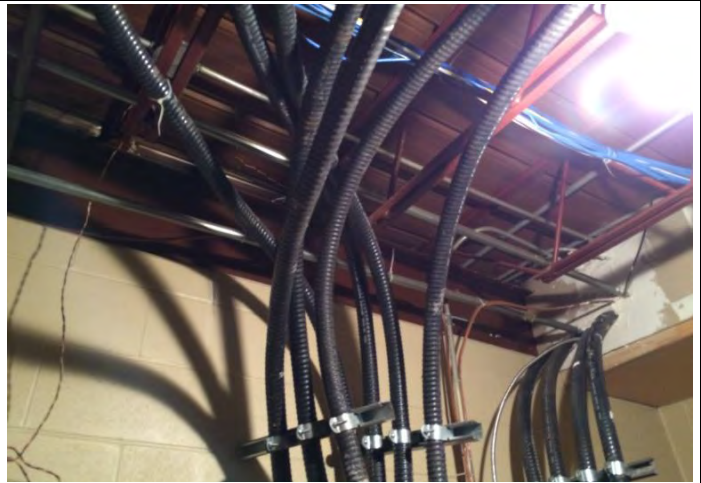
Subject	Observations/Comments	Recommendations	Photo Reference
Service and Distribution	<ul style="list-style-type: none"> The incoming service is underground from a nearby pole to the main electrical room in the basement. The main switchboard is rated for 1200A @ 120/208V. The whole building is supplied by a 240kW generator which was installed during the original construction in 1975. The transfer switch for the generator is a Westinghouse 'Robonic' model and is also original construction. At 1200A, this switchboard is oversized by more than a factor of 2. Behind the building, there is a receptacle for connecting a standby generator as backup for essential building systems in the event of the main generator failure. The single conductor cables between the switchboard and transfer switch do not have the required spacing between them as is required by code. This could potentially cause local overheating of the cable and degrade the insulators. The load and normal feeders from the transfer switch seem to share a neutral back to the main switchboard. A feeder from the electrical room has been installed with Loomex (NMD90). There is an equipment dryer placed in front of a branch panel "D" next to the rear overhead truck doors. This restricts access to the equipment and is a Code Violation (1m clearance is required). A branch panel in the electrical room is missing some blank fillers. The busbars are exposed. This is a safety issue. 	<ul style="list-style-type: none"> Provide cable supports on the single conductor cables to maintain 1 cable diameter spacing between cables. This will prolong the life of the cables. Relocate the equipment dryer in front of panel "D" at least 1m away from the front face of the panel. Install blank fillers in the branch panel to conceal the busbars and replace the receptacle in the janitor's room with a GFCI type receptacle. 	E-03 E-04

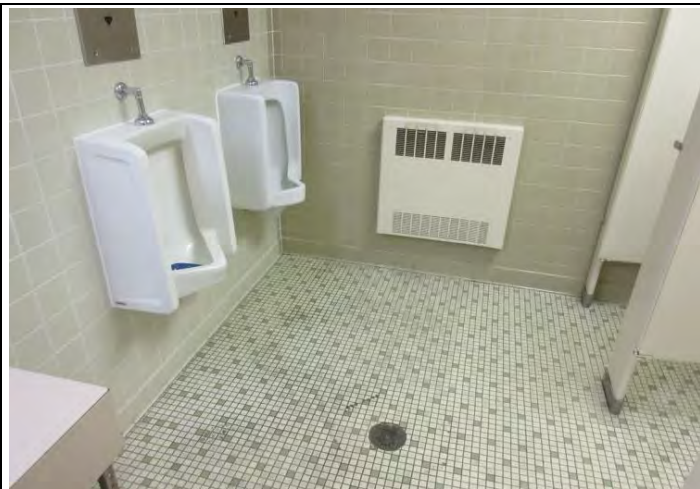
M-07

<p>Plumbing</p>	<ul style="list-style-type: none"> • The washrooms noted on site appeared in relatively fair to new condition. • The washroom fixtures at the Apparatus Bay were in fair to poor condition. 	<p>M-07</p>

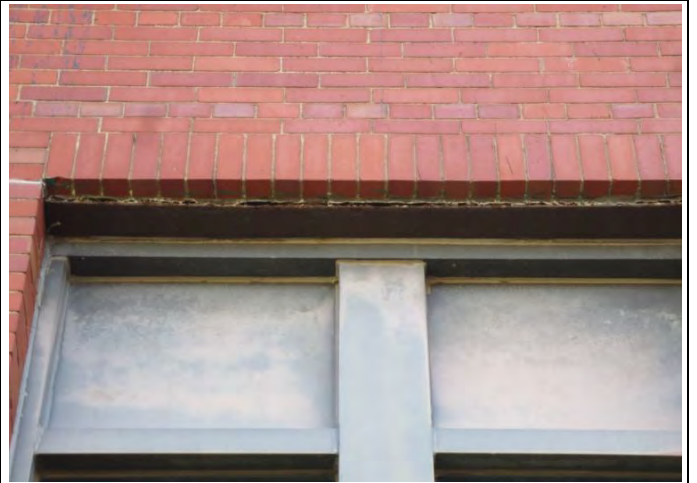
Walls & Ceilings	<ul style="list-style-type: none"> • Generally the interior walls and ceilings of the office areas are in good condition having been updated in 2012. • Furnace room plaster over structural concrete beams is severely cracked and spalling. • Electrical room in poor condition with significant paint peeling on walls and ceiling along exterior wall. • Mechanical room clay tiles are in poor to fair condition with peeling paint and section loss. 	<ul style="list-style-type: none"> • Repair and paint damaged plaster in furnace room for cosmetics. • Remove and repaint walls and ceiling in electrical room. • Remove and replace damaged and deteriorated clay tiles in mechanical room. Clean, prepare, and paint all tiles for regular maintenance. 	S-03
Doors & Windows	<ul style="list-style-type: none"> • Large bronze doors in good condition. • West side window lintels are corroded and delaminated. No interior damage was noted as a result of the exterior observation. Windows in good condition. 	<ul style="list-style-type: none"> • Clean and caulk damaged steel lintel to prevent possible water infiltration. 	S-04

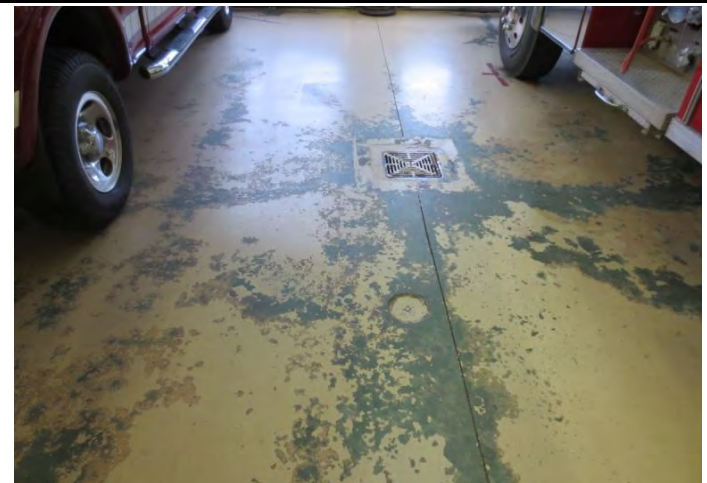
Subject	Observations/Comments	Recommendations	Photo Reference
Foundations	<ul style="list-style-type: none"> Reinforced concrete foundation with gypsum board interior in good condition. Concrete foundation wall running east/west acting as retaining wall for truck bay has no stress cracks or deformations, in good condition. Reinforced concrete basement entrance stairwell, east side, has visible moisture infiltration on steps and adjacent walls. 	<ul style="list-style-type: none"> Further investigation is required to determine the cause of moisture infiltration in the basement entrance stairwell. Once investigated, restoration work to be completed along exterior wall to remove moisture and dampness. 	
Slab-on-grade	<ul style="list-style-type: none"> Generally, painted concrete slab-on-grade in truck bays in good condition. Significant paint peeling present in the 2 north-west bays. Joint filler missing within damaged bays. Exterior concrete ramp and stair, west side, cracked in poor condition. Concrete entrance platform recently replaced and in good condition. Settlement between new and old construction has caused significant concrete damage. 	<ul style="list-style-type: none"> Prepare and paint damaged truck bays to protect structural slab-on-grade from chemical and chloride attack. Remove and replace joint filler in damaged areas. Remove and replace damaged elements of concrete ramp and stair to prevent weakening of the concrete due to freeze/thaw, resulting in potential tripping hazard. 	S-05

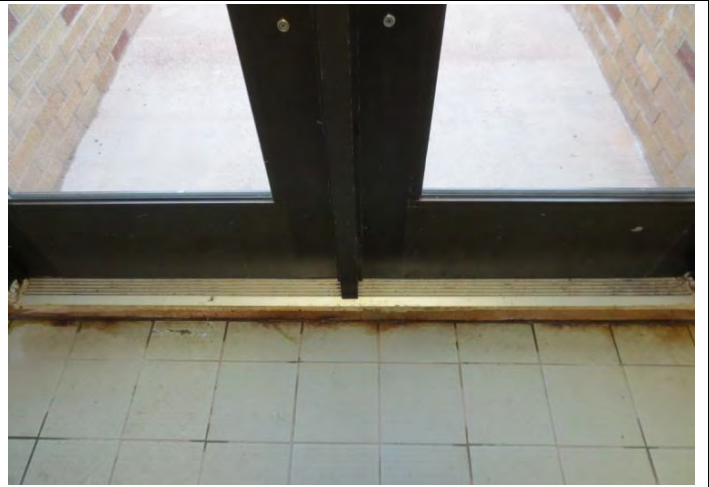
Walls & Ceilings	<ul style="list-style-type: none"> Painted masonry and gypsum board/stud walls are well maintained and in good condition. Suspended tile throughout and painted gypsum board ceilings are without staining and in good condition. 	<ul style="list-style-type: none"> No deficiencies observed. Maintain and provide continuous care. 	
Floor Finishes	<ul style="list-style-type: none"> Generally in good condition; south entrance tile floor in need of cleaning. Linoleum threshold is peeling creating a tripping hazard. 	<ul style="list-style-type: none"> Repair floor and wall finishes in south entrance for moisture control, good housekeeping, and cosmetics. 	
Doors & Windows	<ul style="list-style-type: none"> South entrance door threshold in poor condition. Water infiltration present with signs of staining. OH Doors in good condition; replacement of east doors addressed. Windows in good condition. 	<ul style="list-style-type: none"> Repair or replace south entrance door threshold to prevent further damage of the entryway and floor finishes. 	S-08

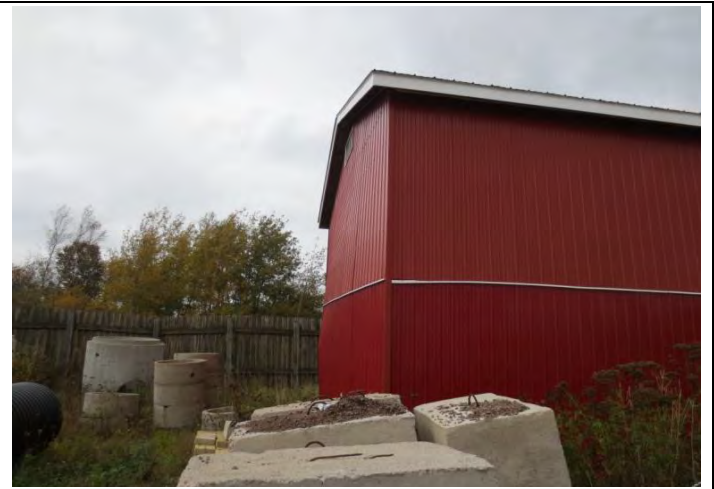
Subject	Observations/Comments	Recommendations	Photo Reference
Foundations	<ul style="list-style-type: none"> Wood foundations supporting wood sill and metal siding in poor to fair condition. Significant bowing of wood sill visible at areas of damage to the wall system, see Building Structural Components for additional information. 	<ul style="list-style-type: none"> See Building Structural Components for recommendation. 	
Slab-on-grade	<ul style="list-style-type: none"> Slab-on-grade not visible for review. 	<ul style="list-style-type: none"> No recommendations at this time. 	
Building Structural Components	<ul style="list-style-type: none"> Wood truss roof construction with heavy timber columns and wood K-braces at the building corners in fair to good condition. Layered plywood protection boards prevent a complete structural review. Exterior visual inspection shows significant 	<ul style="list-style-type: none"> Further structural review required immediately to determine status of structural elements. It is recommended to remove sand and plywood protection boards to complete the inspection. Structural 	S-14 S-15

<p>deformation of metal siding due to the interior pressures and impact forces associated with loading and storing sand. Reinforcement of central west wall columns visible above plywood protection boards. As a result of the incomplete review, the structural integrity of the wall assembly is unknown and assumed unstable and inadequate.</p>	<p>reinforcement may be recommended.</p>
