Asset Management Assessment

Final Report

Town of Amherst

**TOWN OF AMHERST
ASSET MANAGEMENT ASSESSMENT**

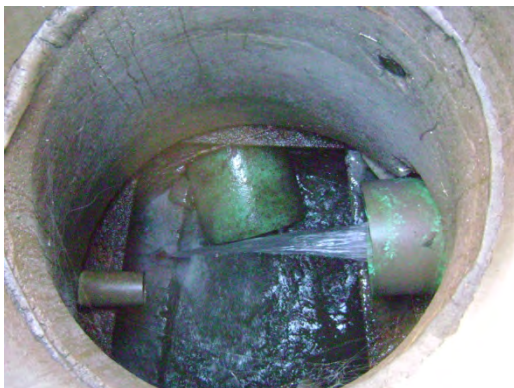
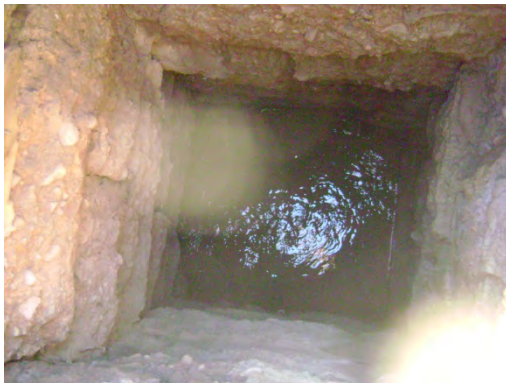
The Town of Amherst has over 72,000 metres of sanitary/combined piping that conveys sewage to six pump stations and ultimately to the new wastewater facility. This piping can be in excess of 100 years in age and consist of various pipe materials. SLI have reviewed GIS mapping, a sanitary sewer database provided by the Town which identifies age, material type, history with a rating for priority and a random in field view of some manholes. Through our filed review and discussion with Town staff it was learned that generally old brick manholes have seen repairs and or replacement of risers and that manholes are functioning. Typical older manhole conditions are exhibited in the photos below.

SLI has not been provided with CCTV inspection reports and did not conduct video inspection during the one day field overview. The Town of Amherst identified on site that full infrastructure replacement

To establish a priority ranking for pipe repair and potential replacement, SLI is of the opinion that additional information should be collected such that a rating for each pipe and manhole in accordance with the NASSCO system can be established. This is typically a PCAP and MCAP ratings system that is developed through the analysis of video information and conditions. Cracks, blockages, sagging, joints, signs of infiltration, root penetration, manhole riser and lid leakage and overall conditions are observed. Consideration of Town collected data on repairs and observations would also be integrated into the condition assessment. Once consolidated, a technical process is applied to establish the overall condition of each pipe section and manhole. From this information a capital
